Milner Ridge Case Study

6 years Update

Milner Ridge was a lined waste water lagoon project made entirely out of very erodible sand. The engineer needed a more cost effective vegetation solution than hauling in topsoil.

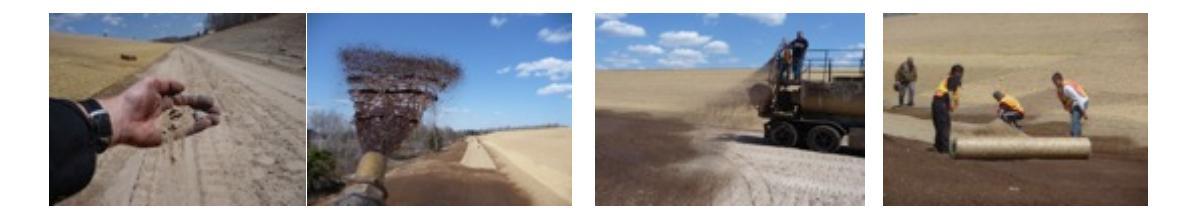
Installation:

Mid Canada Hydroseeding applied Verdyol Biotic Earth Black a hydraulic growth medium (HGM) along with seed water and fertilizer to kickstart mother nature in reclaiming this site. S31 and S32 Straw erosion control blankets were applied over the entire site to prevent erosion of the very loose sands.

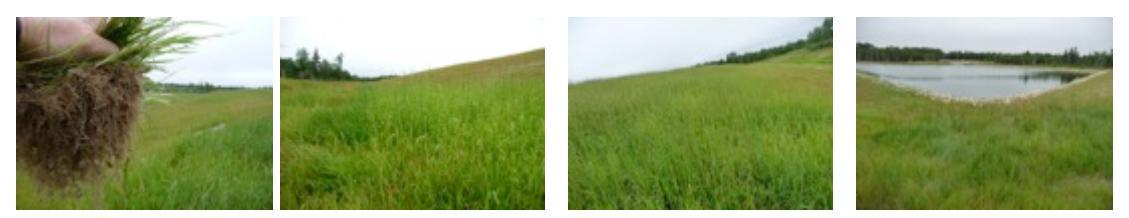
Year One:

A mix of grasses and legumes where planted, the sod forming grasses showed exceptionally well in the first year locking the sand with a dense root mass thus preventing all erosion of the lagoon.

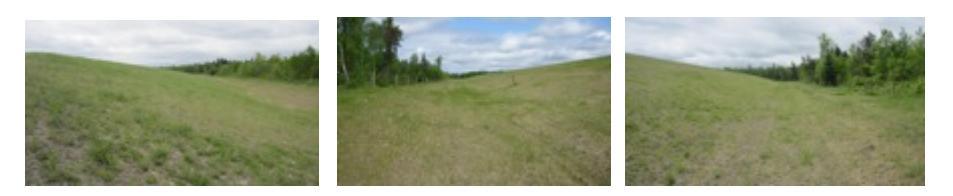
Year Three:

Slowly over time due to lack of nutrients in the sand the grasses started to weaken and the nitrogen fixing legumes (clover, birds foot trefoil and alfalfa) started to fill in. To date no erosion on the cell has occurred.

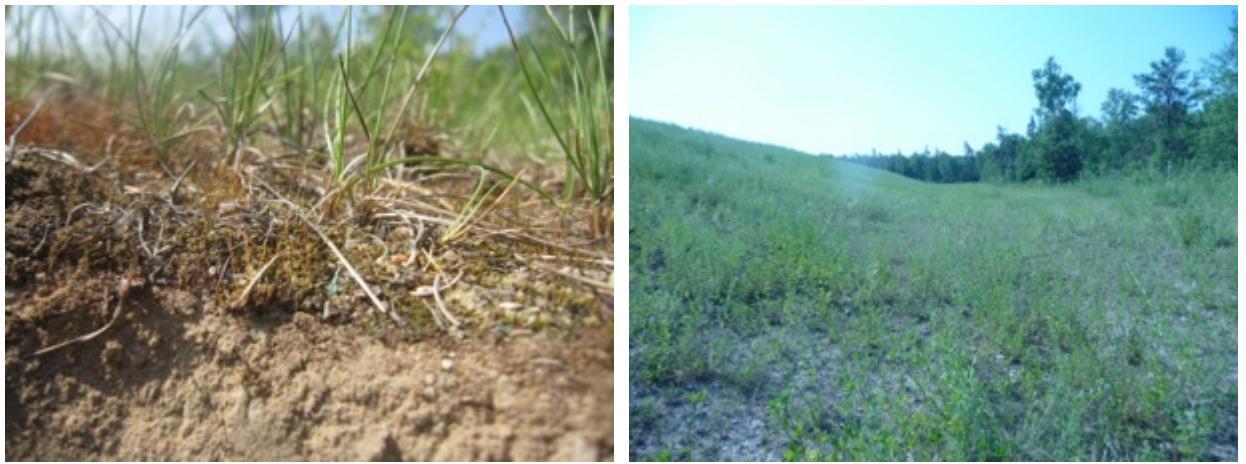
Year Five:

The Verdyol Biotic Earth layer has been successfully replaced with a new growing layer that will support the vegetation over the long run. Mosses native to the area (boreal forest) are flourishing along with the grasses and legumes.

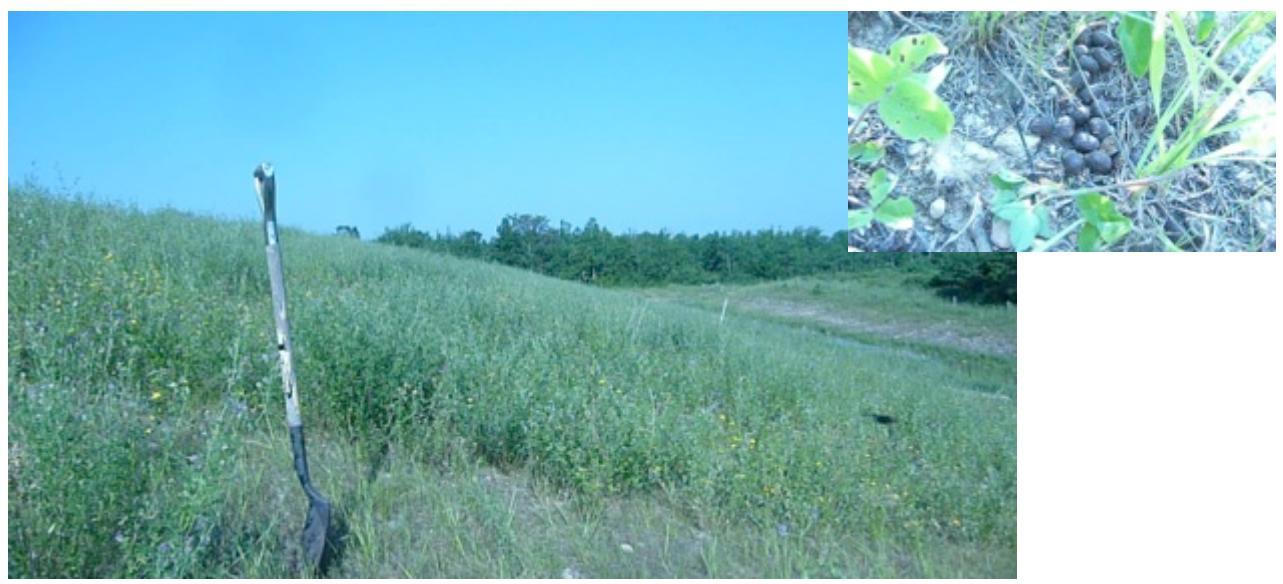
Areas with dense legume vegetation had evidence of deer that have been grazing helping to contribute to the nutrient recycling and soil building efforts.

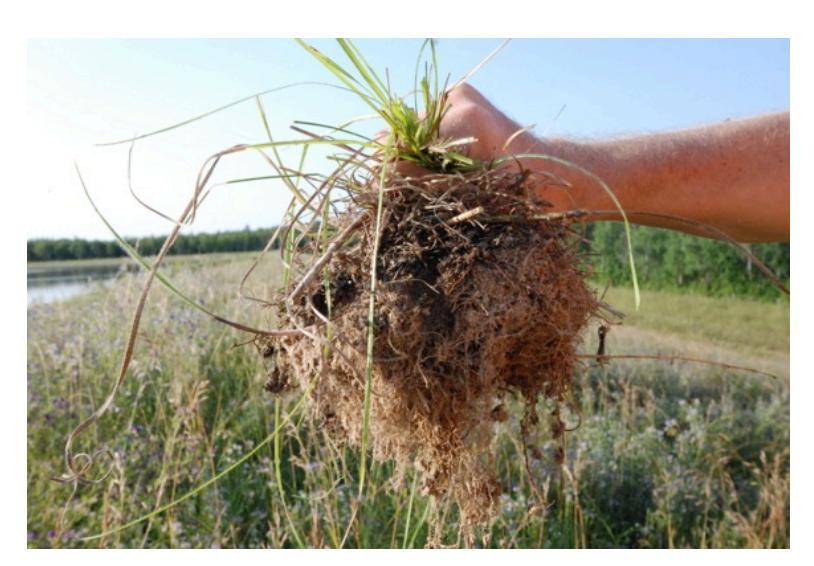
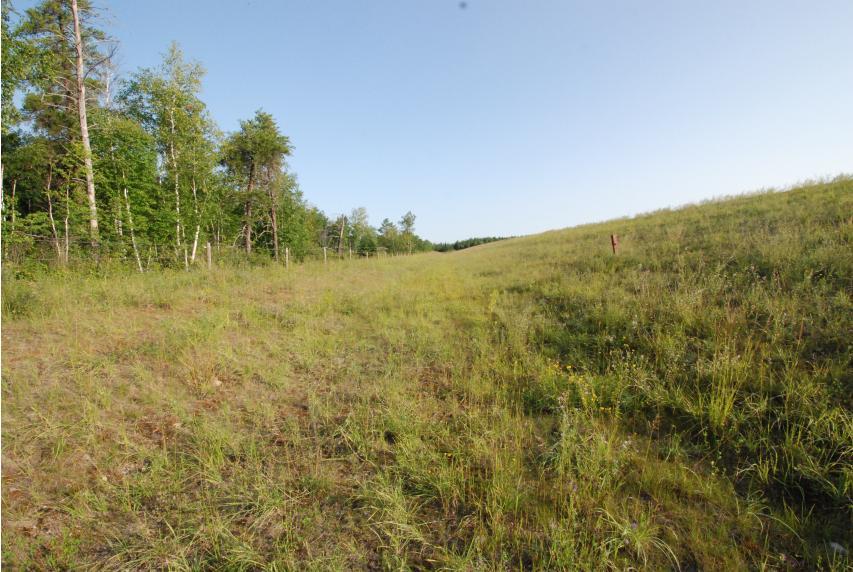
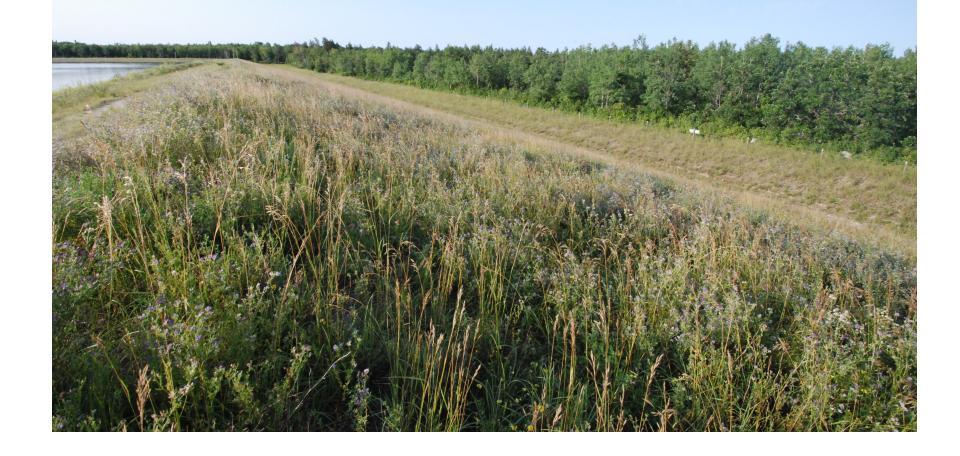
Year Six:

A quick dig into the soil layer reveals a very robust and strong organic layer that is growing and supporting strong growth of vegetation.

Large white tail deer where seen grazing this slope taking advantage of the lush vegetation and helping to increase the nutrient cycling process.
